# Terahertz NDT on Insulation Materials

Insulation materials are critical for safeguarding the structural integrity of aerospace vehicles against extreme heat, erosion, and mechanical pressure. **TeraLumen's Terahertz (THz) technology** provides a non-contact, non-ionizing insights for verifying bonding integrity, layer thickness, and subsurface defects.

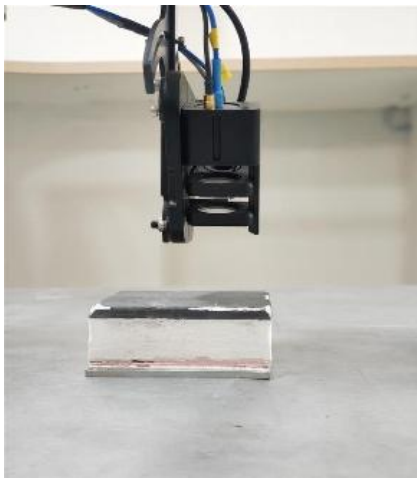
### 1. Silica Tiles

Silica tiles are lightweight, highly porous ceramic insulators engineered for extreme thermal protection. Silica tiles (e.g., LI-900) are made of composite materials that includes silica, alumina-borosilicate and aluminum oxide.

1. **Borosilicate Coating (Top):** Black glass layer shedding ~95% of heat.
2. **Silica Core (Middle):** 90% air / 10% SiO<sub>2</sub> fibers; provides bulk insulation.
3. **Felt/Wool (Interface):** Fiber-based buffer to absorb mechanical stress.
4. **Silicone Adhesive (Glue):** Flexible bond between tile and airframe.
5. **Substrate (Aluminium/CFRP):** The primary structure; acts as a total THz reflector (back-wall).

- **Thermal Properties:** Withstands up to 1,200°C by radiating heat and maintaining low thermal conductivity.
- **THz Transparency:** With a composition of approximately 90% air, the material exhibits a low **dielectric constant (approx. 1.13)** and a low **loss tangent ( $\tan \delta \sim 4 \times 10^{-4}$ )**, making it highly transparent to THz frequencies.

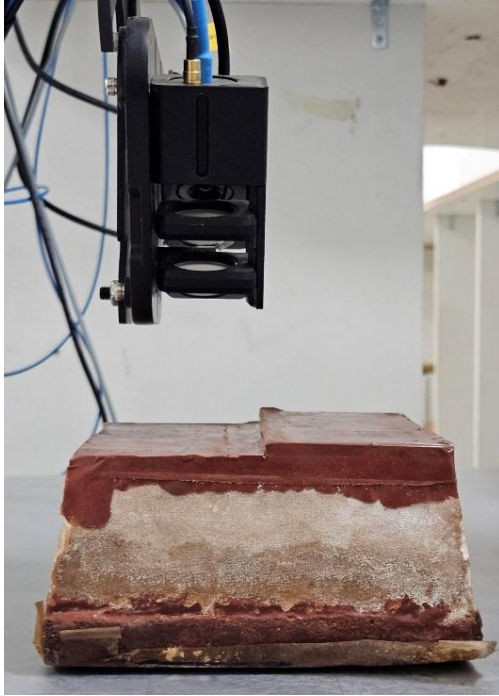
### 2. Inhibition Material:

Inhibition materials (often referred to as **ITP** or **Inhibition Thermoplastic/Polymer**) are critical components in high-heat shielding systems. This material is specialized, high-density compound designed to prevent chemical migration and provide an additional layer of thermal buffering. Unlike the highly porous silica core, these materials are typically dense, often composed of a fluoroelastomer or a refined thermoplastic matrix. They serve as a critical "inhibition" layer, protecting the underlying structural components from the volatile off-gassing or oxidative products generated during extreme thermal cycles. Due to the material's higher dielectric constant (typically 2.0), THz Time-Domain Spectroscopy (THz-TDS) can precisely measure the thickness of the inhibition layer to within tens of microns.
